Service Hints

TH-P50U30V

Plasma Television

Troubleshooting Guide

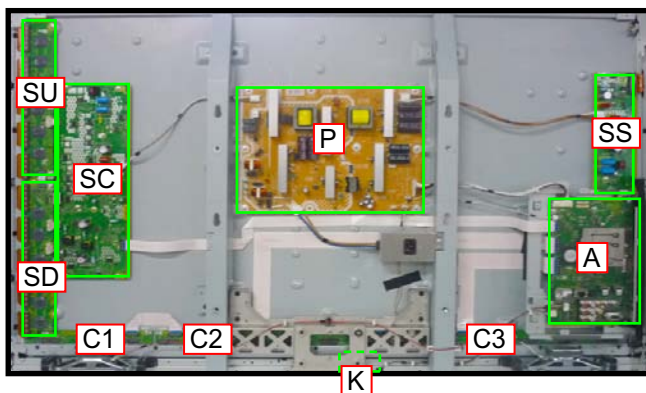
TH-P50U30V / D

Board Name	Function	Parts Number
P	Power Supply Non serviceable. P-Board should be exchanged for service.	N0AE5JK00009
A	Main AV input, processing	TZTNP01MEUV (for TH-P50U30V), TZTNP01MNUD (for TH-P50U30D)
K	Remote receiver, Power LED, C.A.T.S sensor	TXN/K1NNUA42
C1	Data Driver (Lower Right)	TNPA5318
C2	Data Driver (Lower Center)	TNPA5319
C3	Data Driver (Lower Left)	TNPA5320
SC	Scan Drive	TXNSC11JGK50
SS	Sustain Drive	TXNSS11JGK50
SU	Scan out (Upper) Non serviceable. SU-Board should be exchanged for service.	TXNSU11JGK50
SD	Scan out (Lower) Non serviceable. SD-Board should be exchanged for service.	TXNSD11JGK50
—	—	—

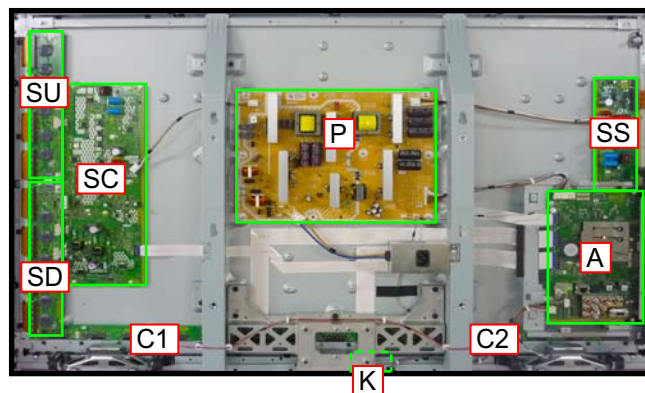
TH-P46U30V

Board Name	Function	Parts Number
P	Power Supply Non serviceable. P-Board should be exchanged for service.	N0AE5JK00009
A	Main AV input, processing	TZTNP01MFUV
K	Remote receiver, Power LED, C.A.T.S sensor	TXN/K1NNUA42
C1	Data Driver (Lower Right)	TNPA5316
C2	Data Driver (Lower Left)	TNPA5317
—	—	—
SC	Scan Drive	TXNSC1MUUM46
SS	Sustain Drive	TXNSS1MUUM46
SU	Scan out (Upper) Non serviceable. SU-Board should be exchanged for service.	TXNSU1MUUM46
SD	Scan out (Lower) Non serviceable. SD-Board should be exchanged for service.	TXNSD1MUUM46
—	—	—

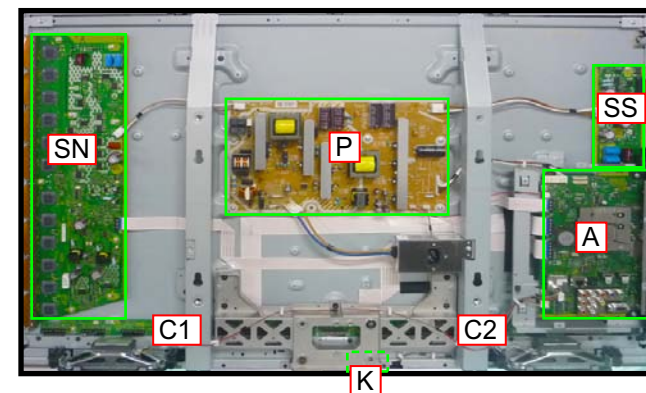
TH-P42U30V / D

Board Name	Function	Parts Number
P	Power Supply Non serviceable. P-Board should be exchanged for service.	N0AE5JK00008
A	Main AV input, processing	TZTNP01MGUV (for TH-P42U30V), TZTNP01MQUD (for TH-P42U30D)
K	Remote receiver, Power LED, C.A.T.S sensor	TXN/K1NNUA42
C1	Data Driver (Lower Right)	TNPA5314
C2	Data Driver (Lower Left)	TXNC211FHK42
—	—	—
SS	Sustain Drive	TXNSS11FHK42
—	—	—
—	—	—
SN	Scan Drive	TXNSN11FHK42

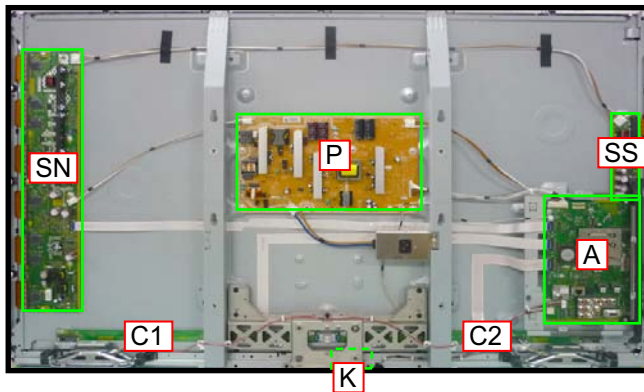
TH-P50X30V / D

Board Name	Function	Parts Number
P	Power Supply Non serviceable. P-Board should be exchanged for service.	N0AE5JK00007
A	Main AV input, processing	TZTNP01MHUV (for TH-P50X30V), TZTNP01MRUD (for TH-P50X30D)
K	Remote receiver, Power LED, C.A.T.S sensor	TXN/K1NNUA42
C1	Data Driver (Lower Right)	TXNC111MGK50
C2	Data Driver (Lower Left)	TXNC211MGK50
SS	Sustain Drive	TXNSS11MGK50
SN	Scan Drive	TXNSN11MGK50

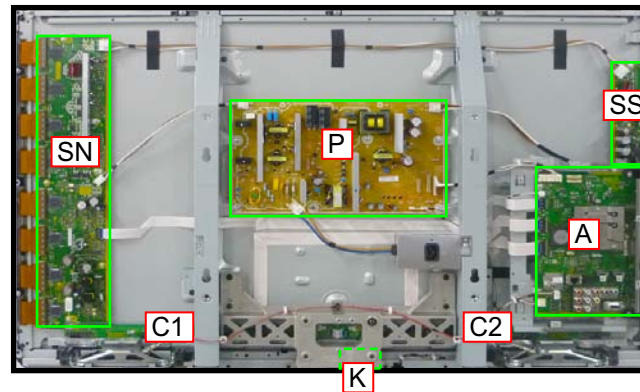
TH-P42X30V / D

Board Name	Function	Parts Number
P	Power Supply Non serviceable. P-Board should be exchanged for service.	N0AE5JK00006
A	Main AV input, processing	TZTNP01MJUV (for TH-P42X30V), TZTNP01MSUD (for TH-P42X30D)
K	Remote receiver, Power LED, C.A.T.S sensor	TXN/K1NNUA42
C1	Data Driver (Lower Right)	TXNC111HHK42
C2	Data Driver (Lower Left)	TXNC211HHK42
SS	Sustain Drive	TXNSS11HHK42
SN	Scan Drive	TXNSN11HHK42

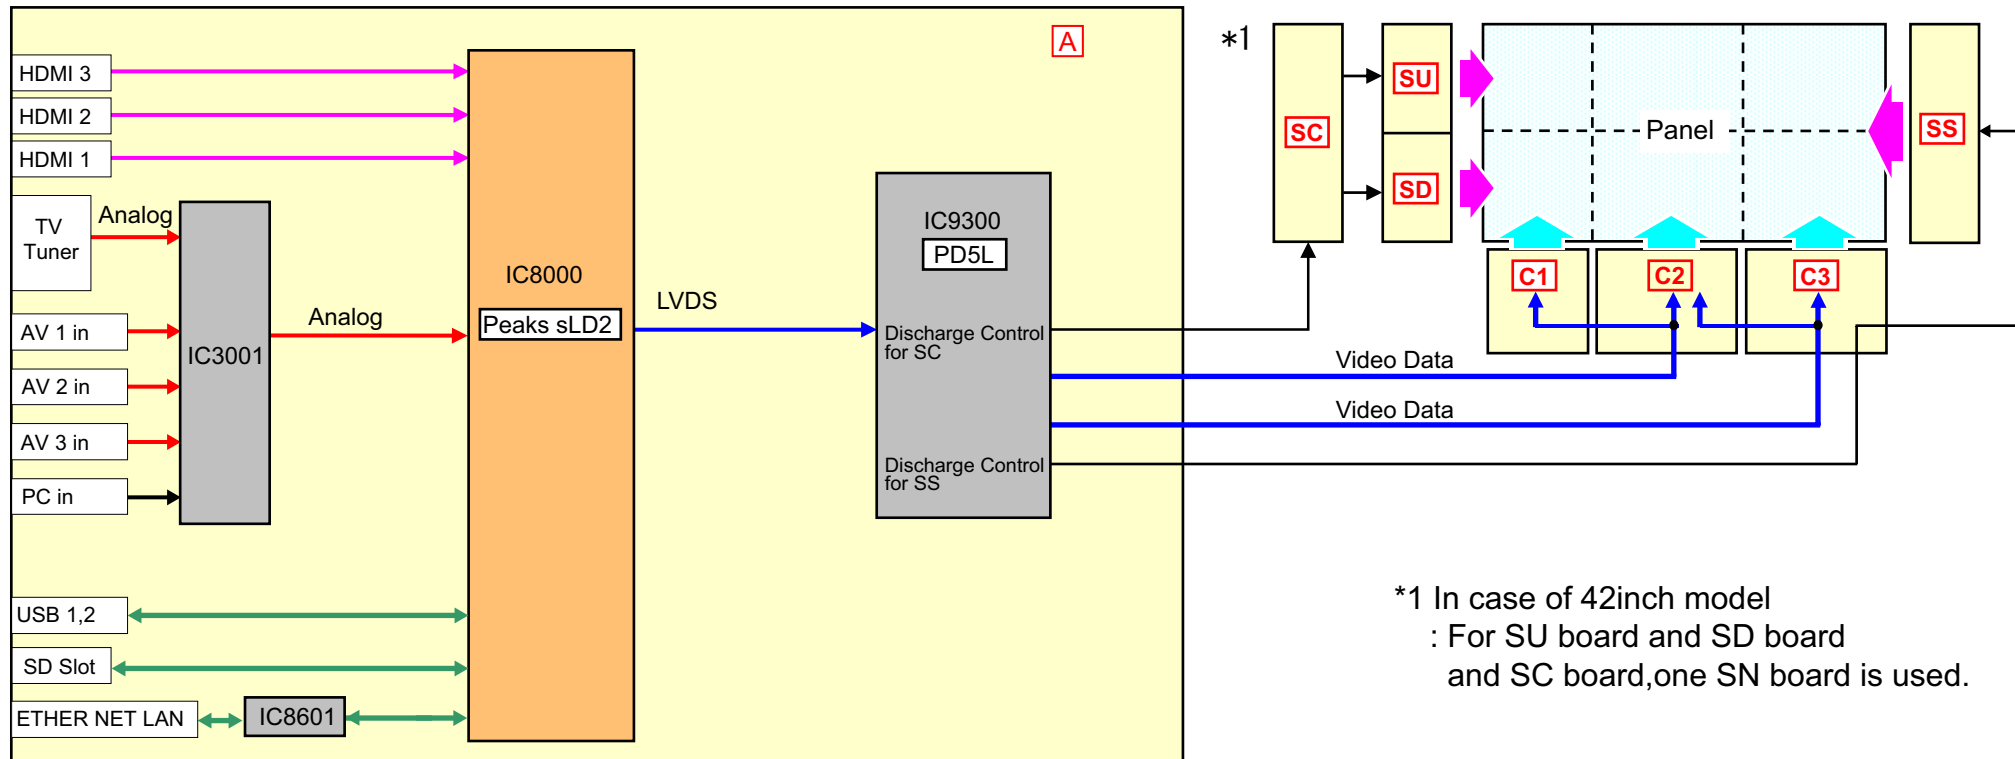
Signal Processing Circuit (1) U30 series

IC3001

: Video Switch
(Audio Switch)

IC8601

: ETHER NET I/F

IC8000

: Peaks sLD2
(Digital Video Processor)

IC9300

: PD5L
[Sub Field Processor,
Discharge Control
Plasma AI]

*1 In case of 42inch model
: For SU board and SD board
and SC board, one SN board is used.

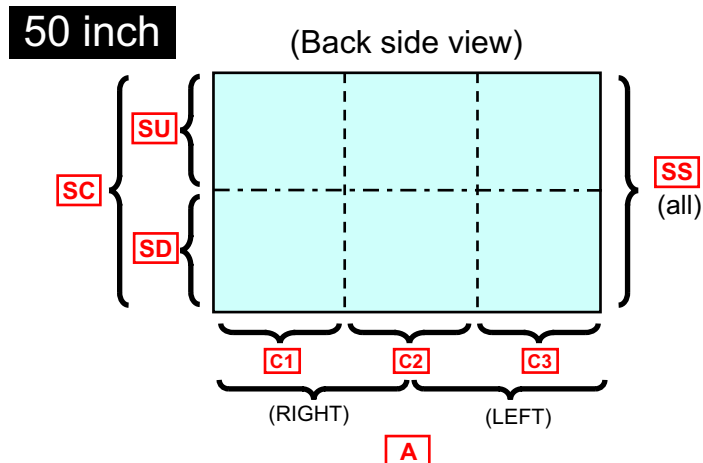
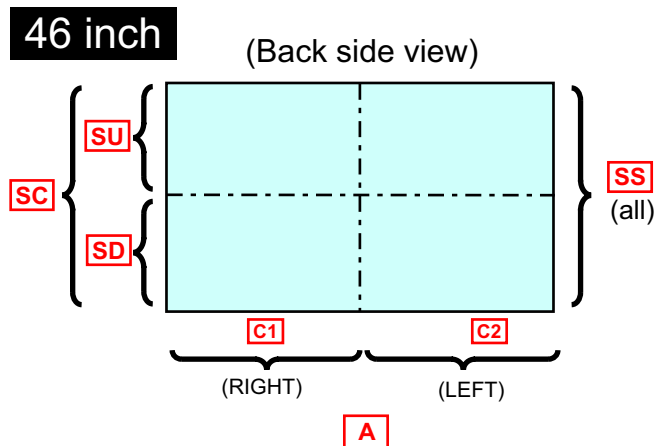
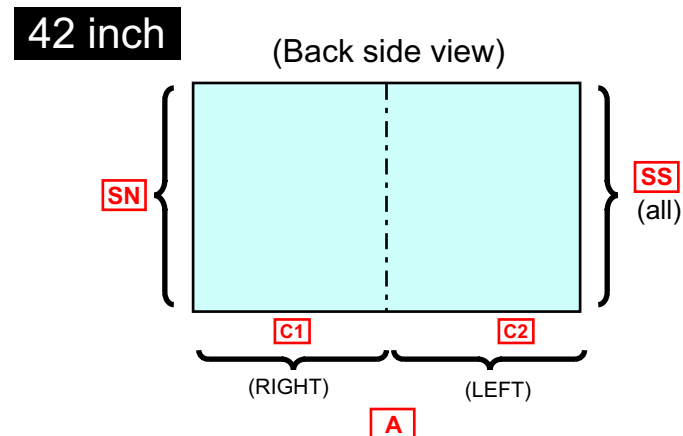
[In case of U30 series]
(Full HD models)

Relation of board and display area (1/2)

You know the possible defective board by picture trouble area.

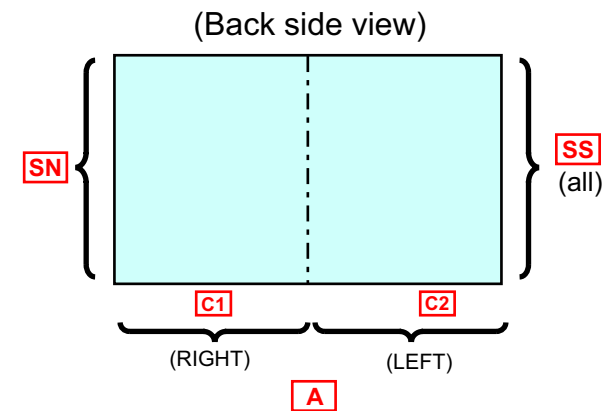
[In case of X30 series]
(HD models)

Relation of board and display area (2/2)

You know the possible defective board by picture trouble area.

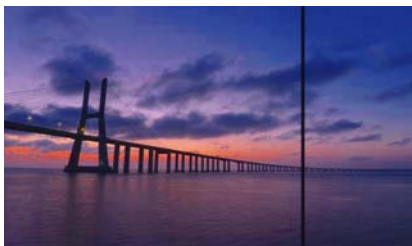
PDP panel defective (Data driver IC defective)

Width is narrower than FPC

Data driver IC defect= PDP panel defect

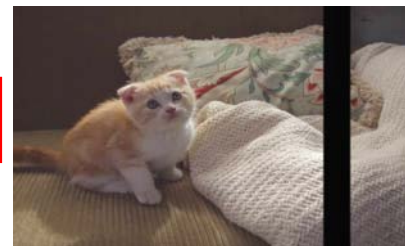
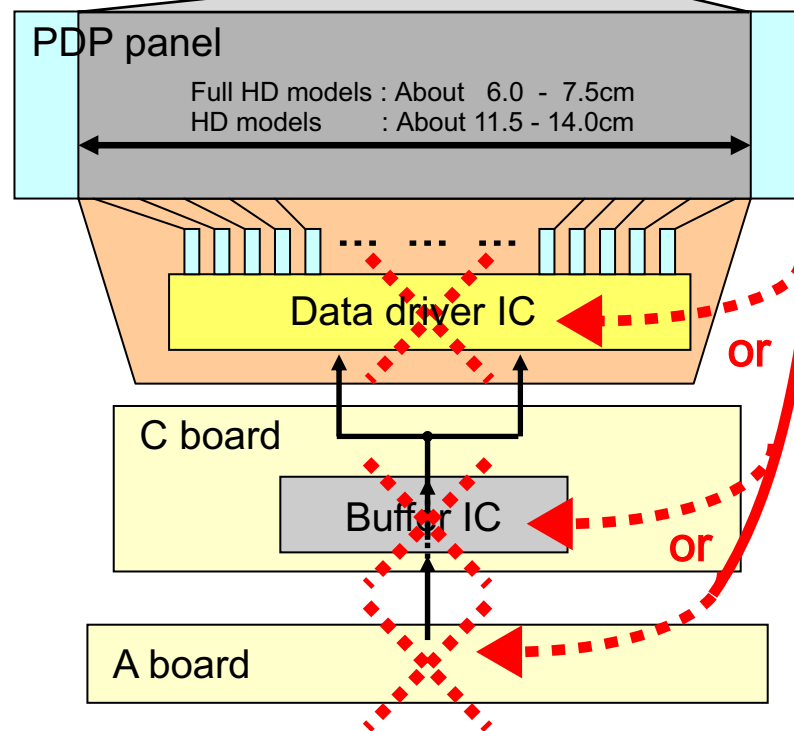
Data driver IC or C or A board defective

Width is same as FPC

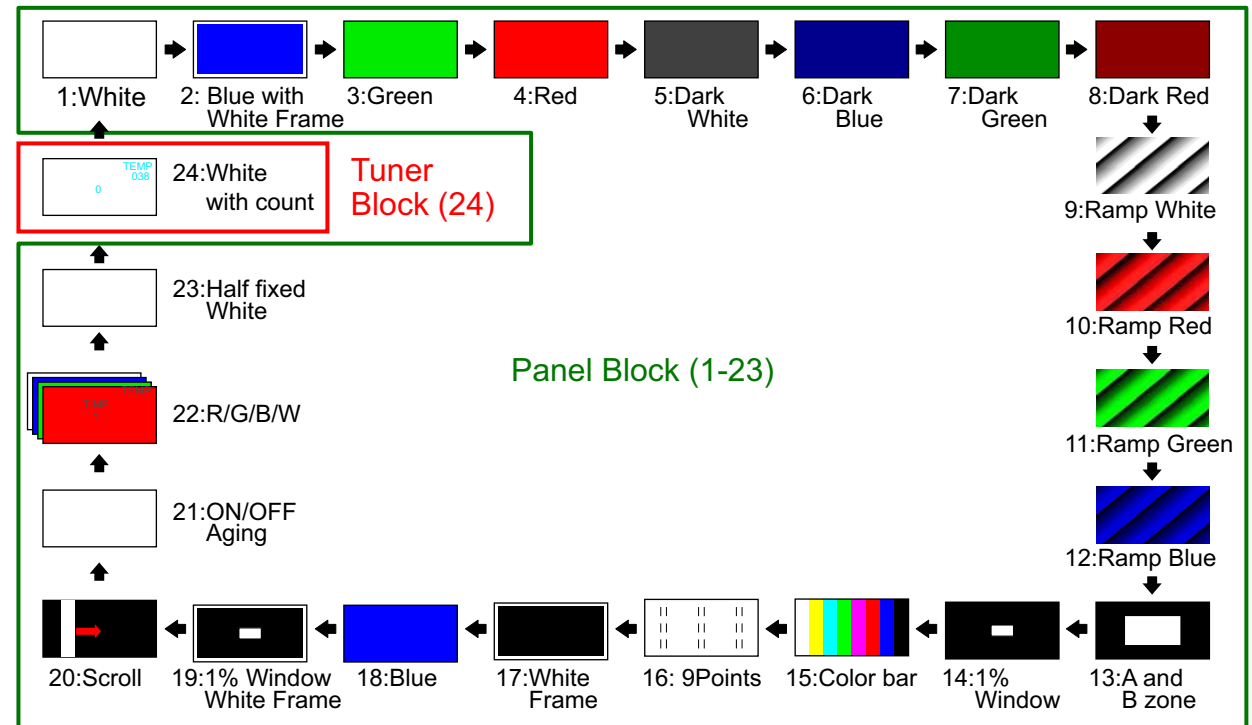
<Test Pattern (Normal)>

<How to enter the Test Pattern>

1. Press the "**VOLUME -**" on the TV set and push "**i**" button of remote controller 3 times at the same time.
2. After this procedure, you can enter "Service Mode" and select "**AGING**", then "Test pattern" will appear.
3. Push "3" button of Remote Controller to select the test pattern mode to forward.
4. Push "4" button of Remote Controller to select the test pattern mode to reverse.

How to diagnose by using test pattern

Test pattern (1-23)	Defective Block (Board)
Abnormal	Panel Block (A Board or Panel)
Normal	Tuner Block (A Board)

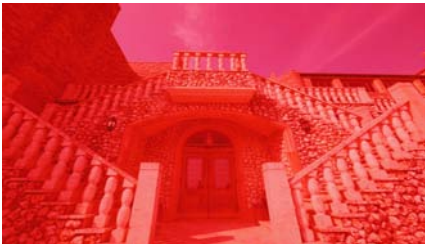
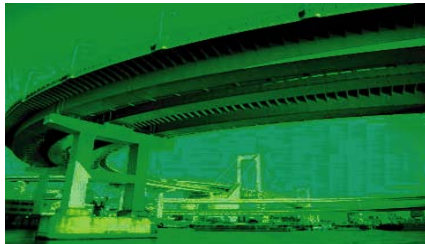
Symptom	Actual symptom	Defective board
Irregular Color

<div>A board</div>
All vertical line

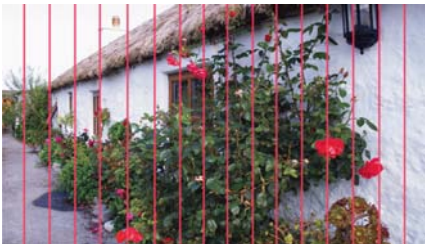
<div>A board</div>
Abnormal electric discharge

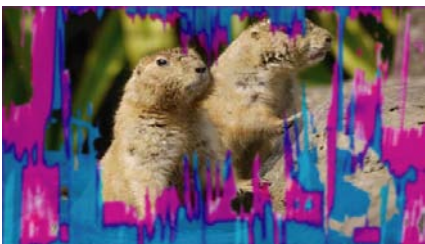
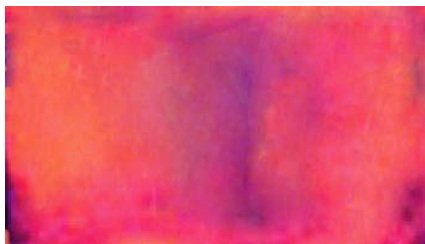
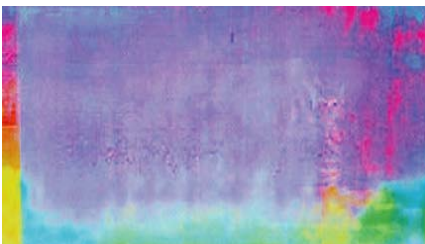
<div> in case of P50/46U30 SC / SS board in case of P42U30 and HD model SN / SS board </div>

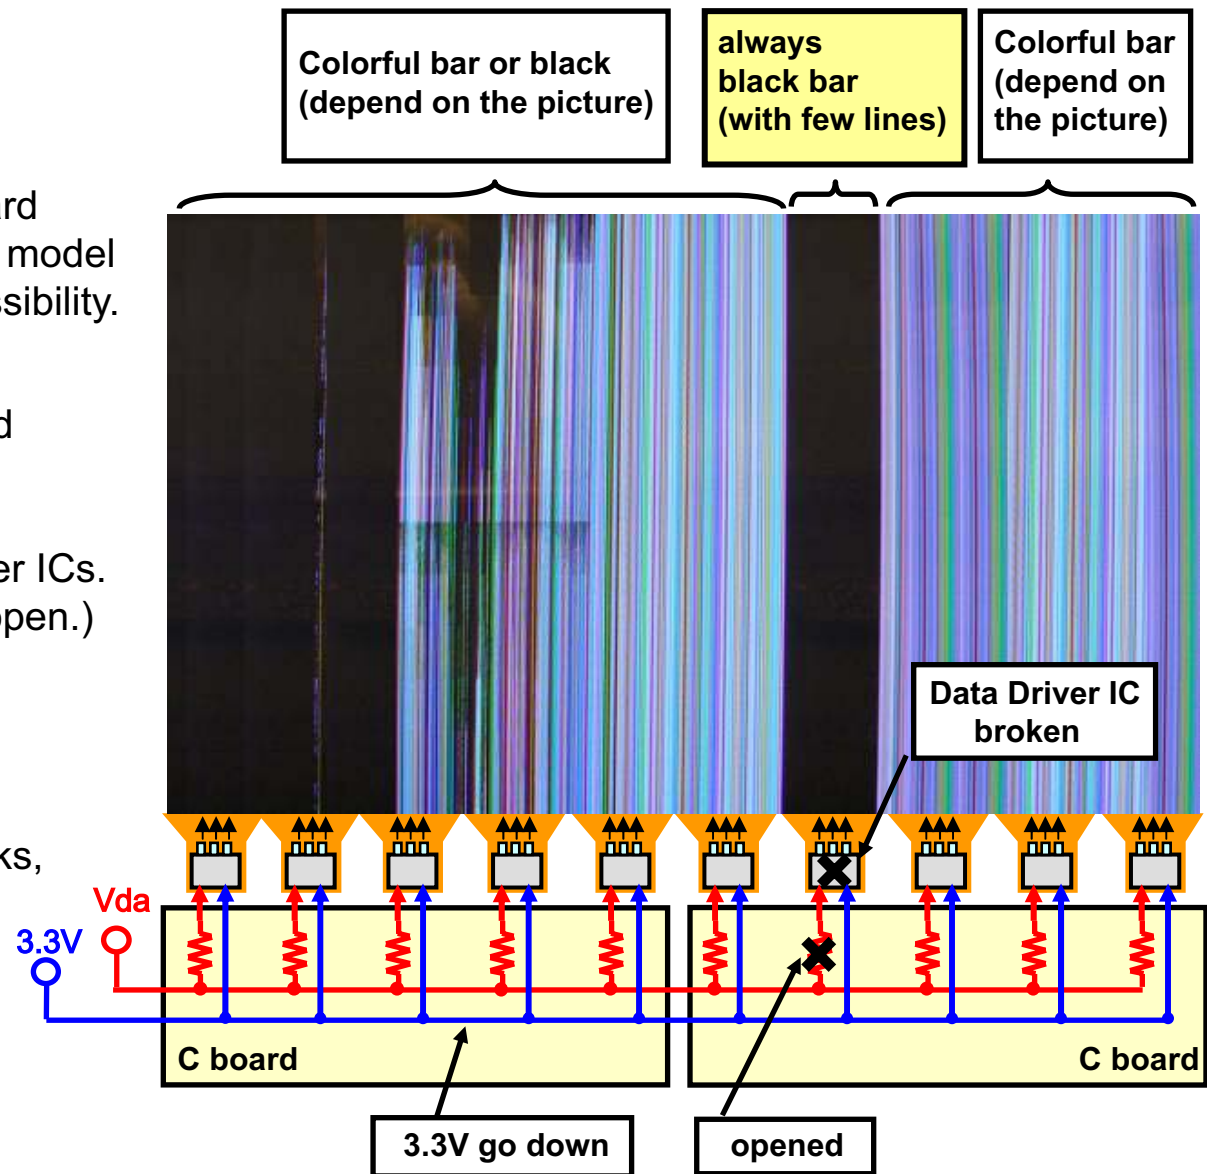
[2] Symptom : Rainbow vertical bar

This symptom is very likely to be the A board defect for the previous model, but for 2011 model the Panel and C board defect is a high possibility.

If one of the Data Driver IC is defective and 3.3V go down, the other Data Driver ICs don't work correctly.
Because 3.3V is common for all Data Driver ICs.
(Vda line is isolated due to resistor being open.)

Check by displaying some images.
If the position (length) of colorful bars change and there are some black bar blocks, the data driver IC is defective.
If there is no black bar block, check the connection of cables between A and C board.
If trouble still persists, the A board could be defective.

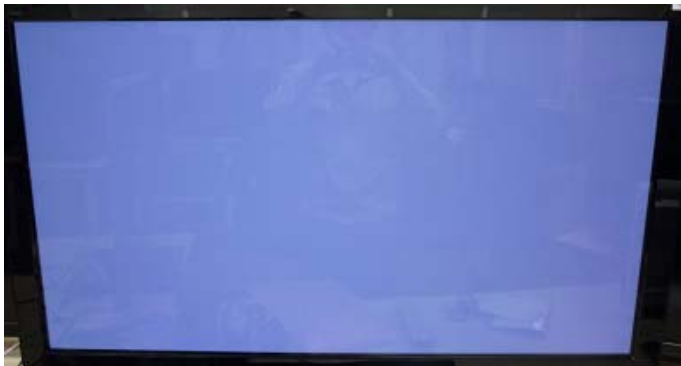
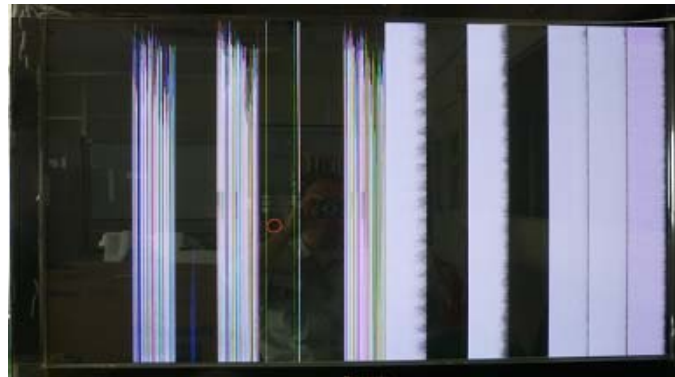
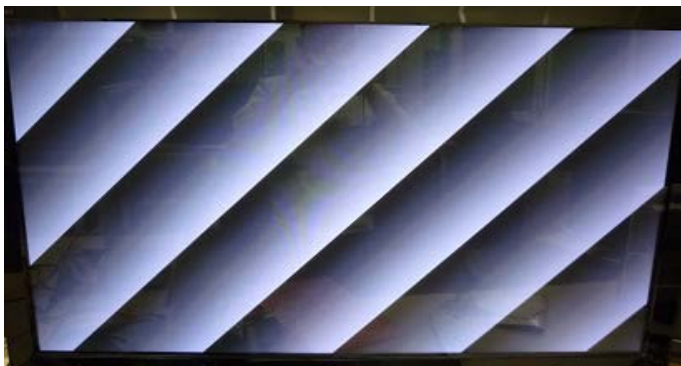
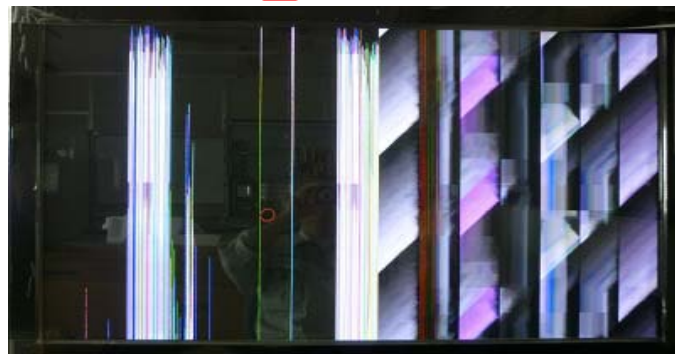
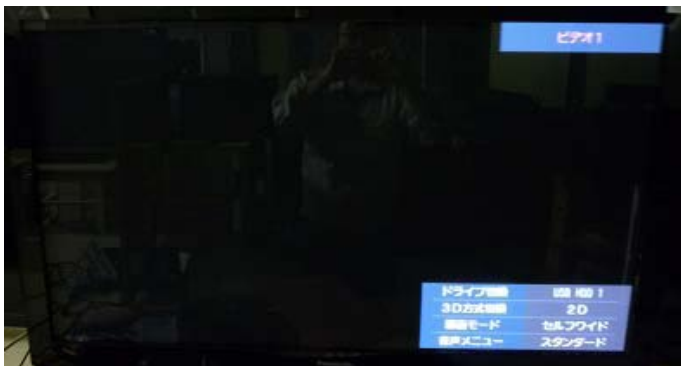
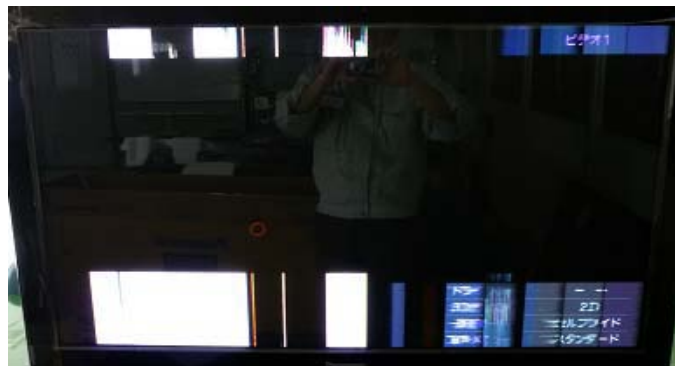
[7] Symptom example (another image)

Normal Image

Defective unit
